THE CONSERVATION OF OTTOMAN ERA NEIGHBOURHOODS IN ISTANBUL: A
CASE STUDY OF ARNAVUTKOY, BESIKTAS

A Dissertation submitted for

MSc in Architectural Conservation,

University of Edinburgh

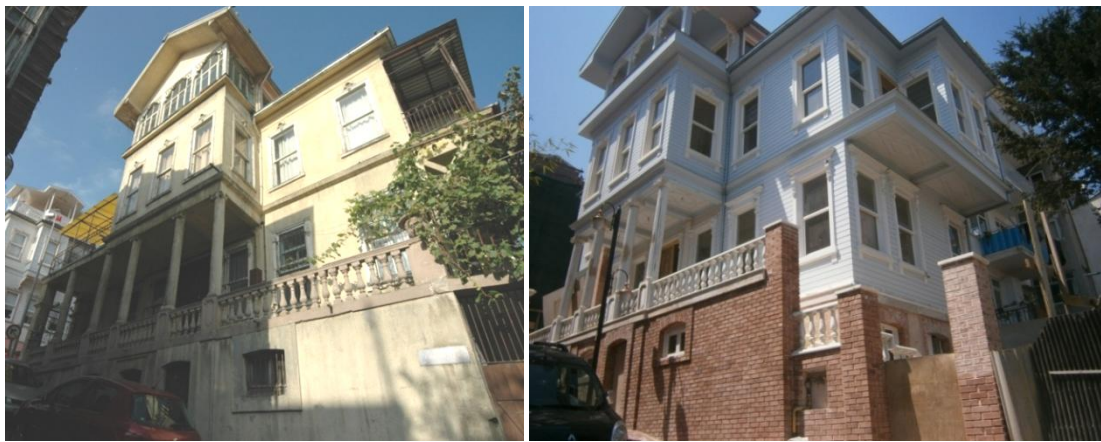
Figure 2: *Above left*, a house before a restoration project in Arnavutköy; *above right*, after the restoration project

It is observed on this site that although the original structure was recorded, the new building does not follow the existing material, form, color or texture and hence it does not become more than imitation.

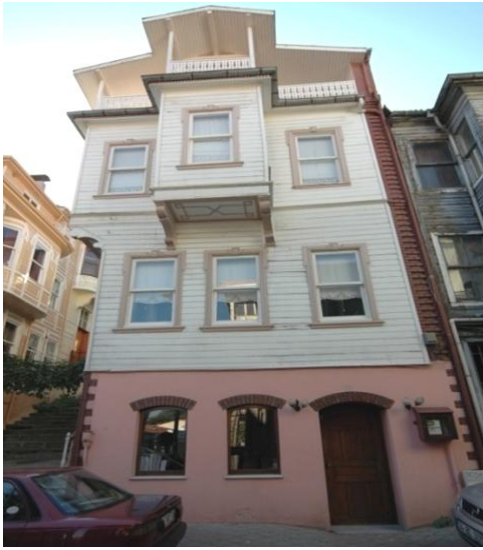
Figure 3: Restitution Project in Arnavutköy

In figure 3, İstanbul Metropolitan Municipality Bosphorus Planning Authority carries out restitution project of II. Listed building which is located on the Beyazgül- Karakavak street.

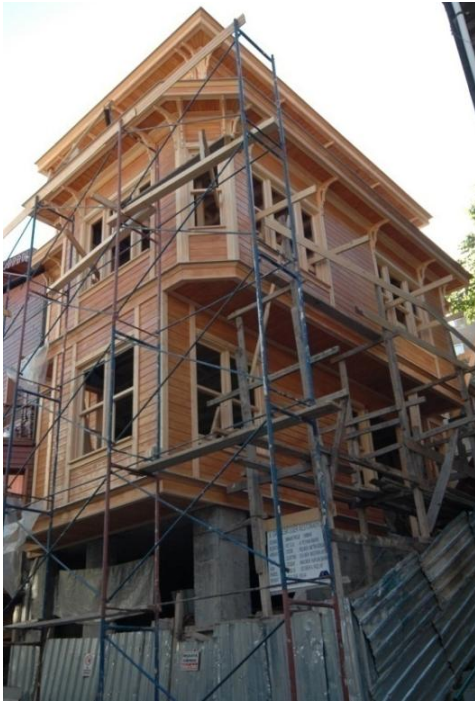
Figure 4: Restoration of II. Listed Building

In figure 4, II. Listed building restoration project in practice shows how restoration is perceived in Istanbul.

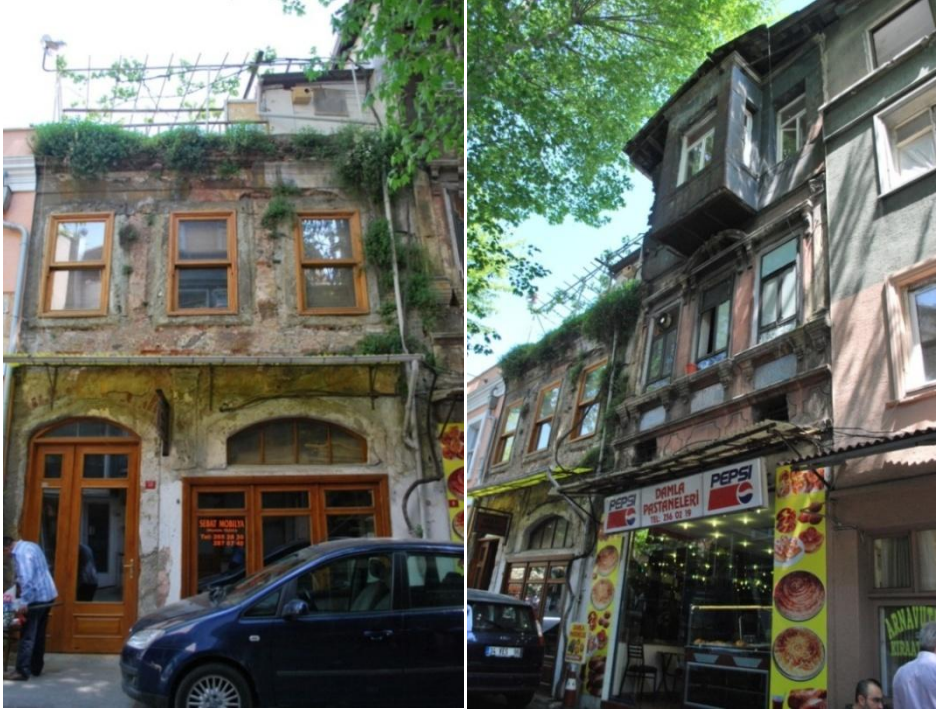
Figure 7: An old building which was damaged from the fires in Arnavutköy

There is no action has taken place for buildings that were damaged in the fires as seen in figure 7, the building barely survives. Two adjoining buildings on Beyazgül Street are in need of restoration especially in this area where commercial activities take place.

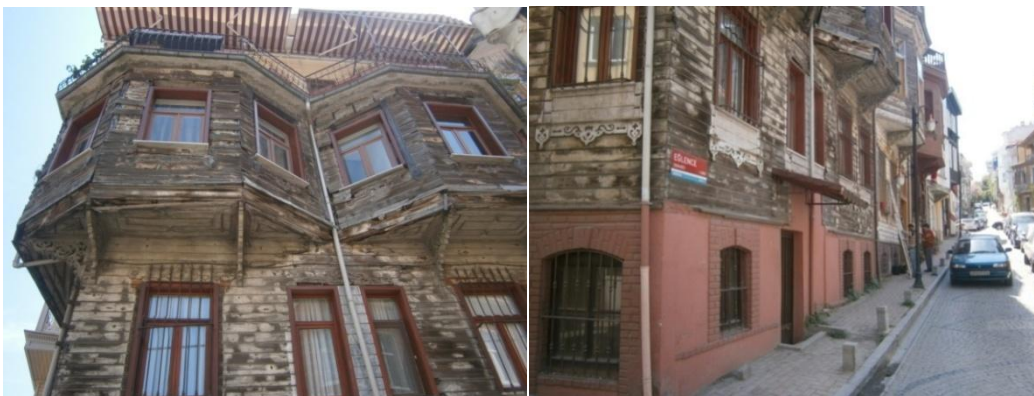
Figure 8: A view from Eglence street

Private house owners in the area are responsible from maintenance of these historic buildings that are neglected as in the figure 8.

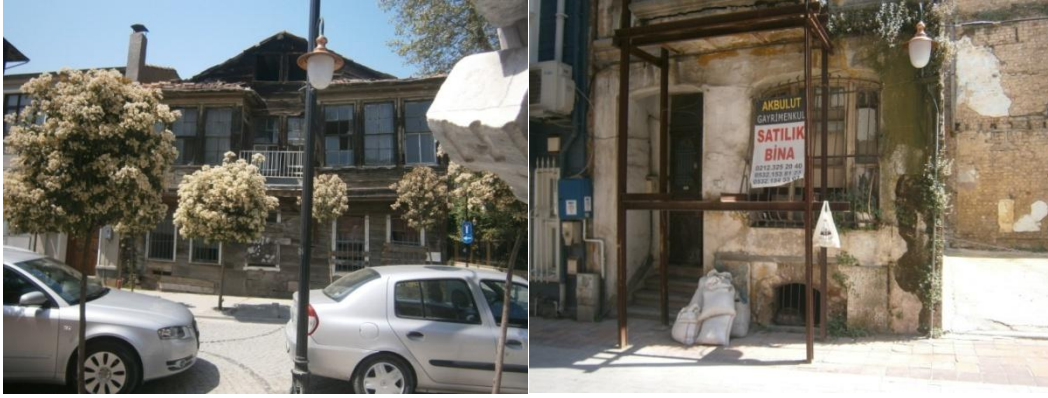
Figure 9: *Above left*, a house across the Bosphorus Sports Club on the Kirechane Street; *right*, a listed ruin, which is located on the Beyazgül- Tayyar Suphi Street

The abandoned buildings barely survive in today's modern lifestyle and that is why people prefer to live in newly built 4 or more storey houses and for this reason, these buildings are left to decay mostly as seen in the figure 9.

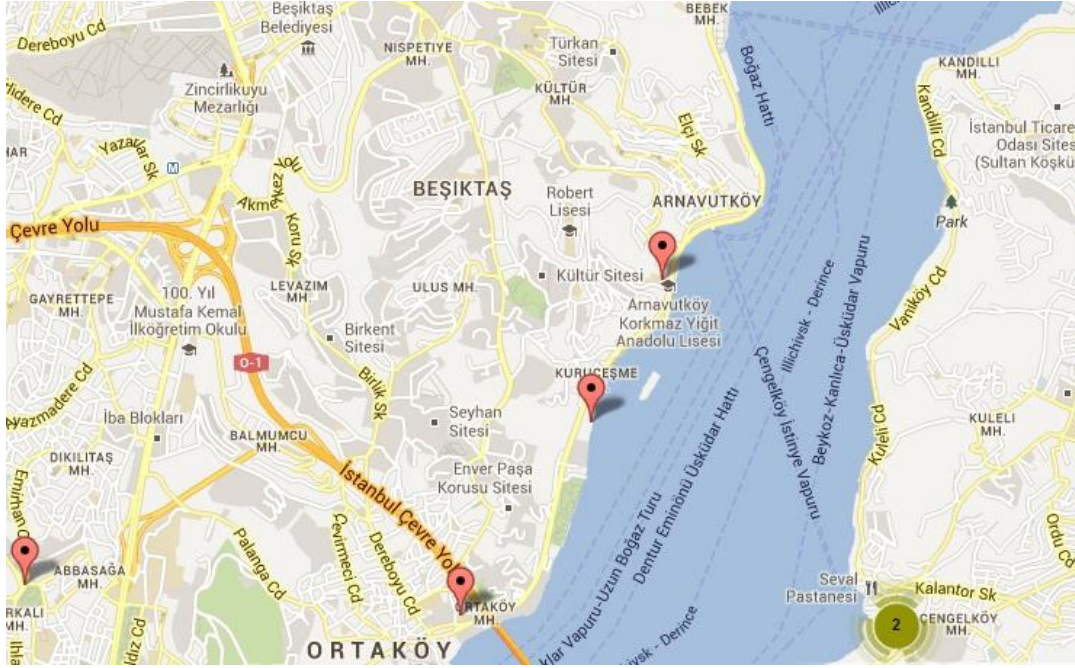
Figure 14: Archeological map of Arnavutköy

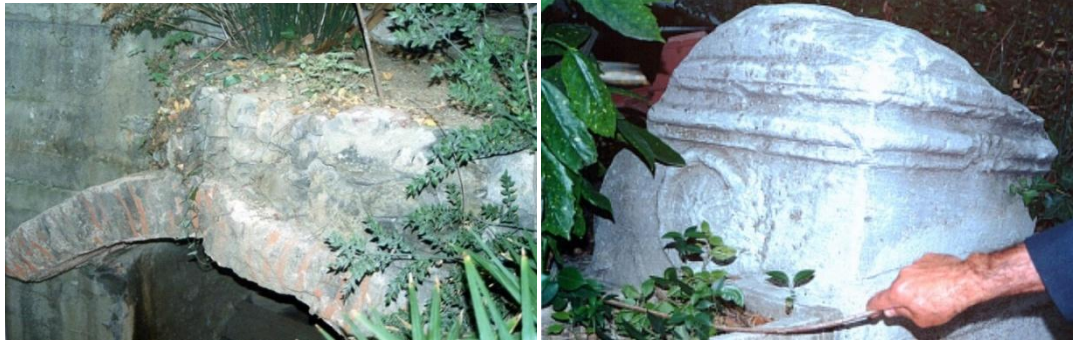
Figure 15: Halil Paşa Yalısı

It is only listed archeological ruin in Arnavutköy and it has layers of Medieval/ Byzantium- Anatolian Seljuk Empires.³⁵ It is in a bad state.³⁶ Among the findings, there is a piece from a

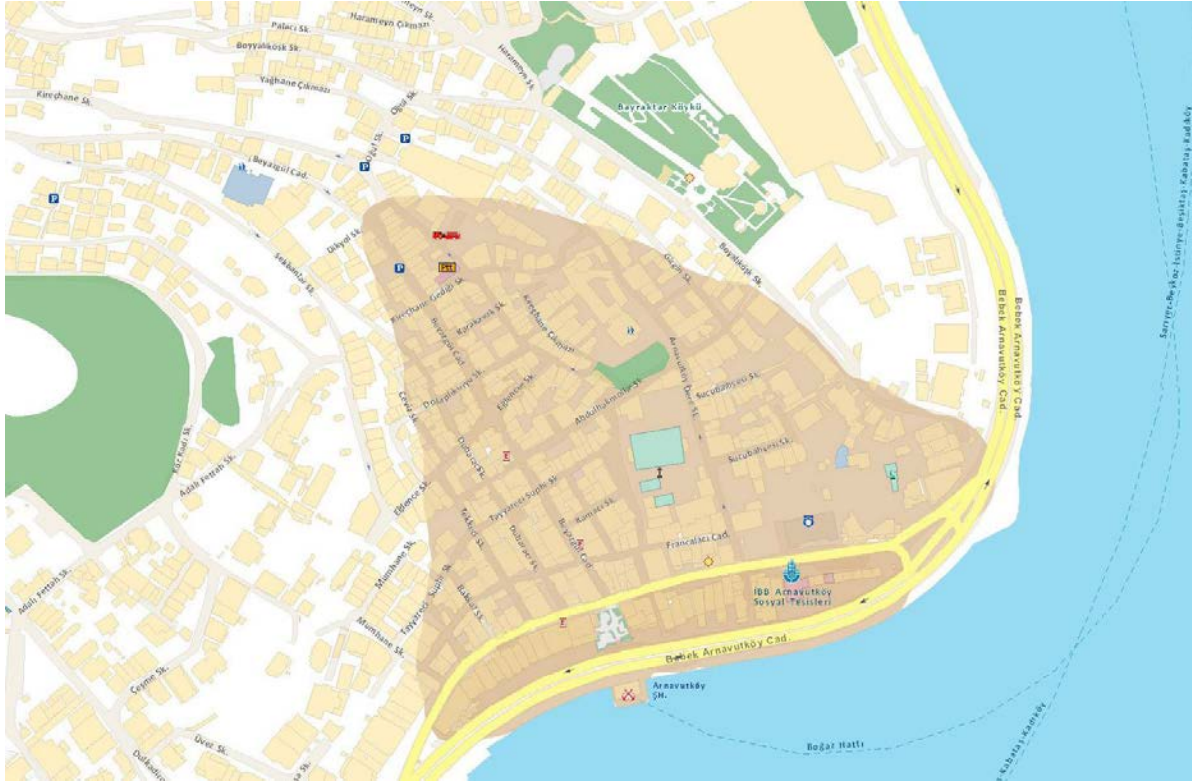
Figure 20: Case study area

The case study area as is shown in the figure 21, there are small plots where buildings become attached to one another. The density of buildings with narrow facades is observed alongside the Bosphorus and also through the Beyazgül Street which becomes linear and almost perpendicular to the coast and ends with an open space. Beyazgül Street is surrounded by row houses that have 3 or more storey and these structures with bay windows that overshadow the street. Car parking on the both sides of these narrow streets is concluded with the occupation of pedestrian way. The parallel streets to Beyazgül Street connect to the Kuruceme Street which is back street of Bebek- Arnavutköy Street and the rear facade of “yalı” s face with Kuruceme Street. The park lost its meaning because of the high density of commercial and residential surrounding areas. Additionally, the traffic flow on the main street, Bebek- Arnavutköy Street interrupts the facade view of coastal settlements and the social facility

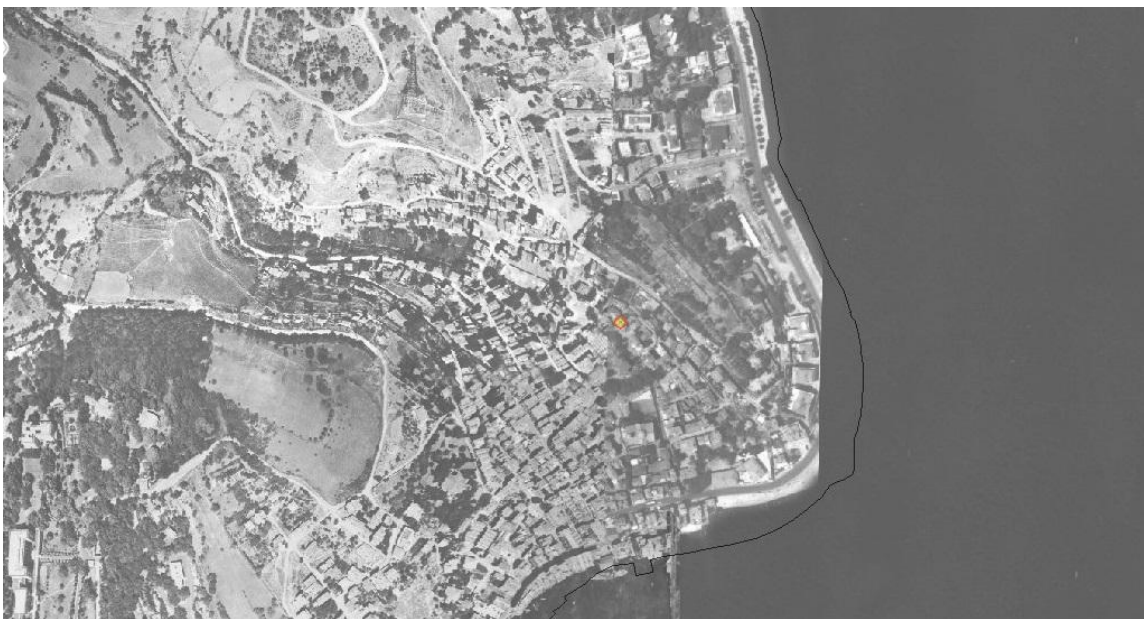
In figure 32, the area in 1946 when the rapid urbanization and modernization with concrete buildings and illegally built houses dominated the core which comprises of Ottoman timber houses.

Figure 32: A map of Arnavutköy (1966) in the scale of 1/5000

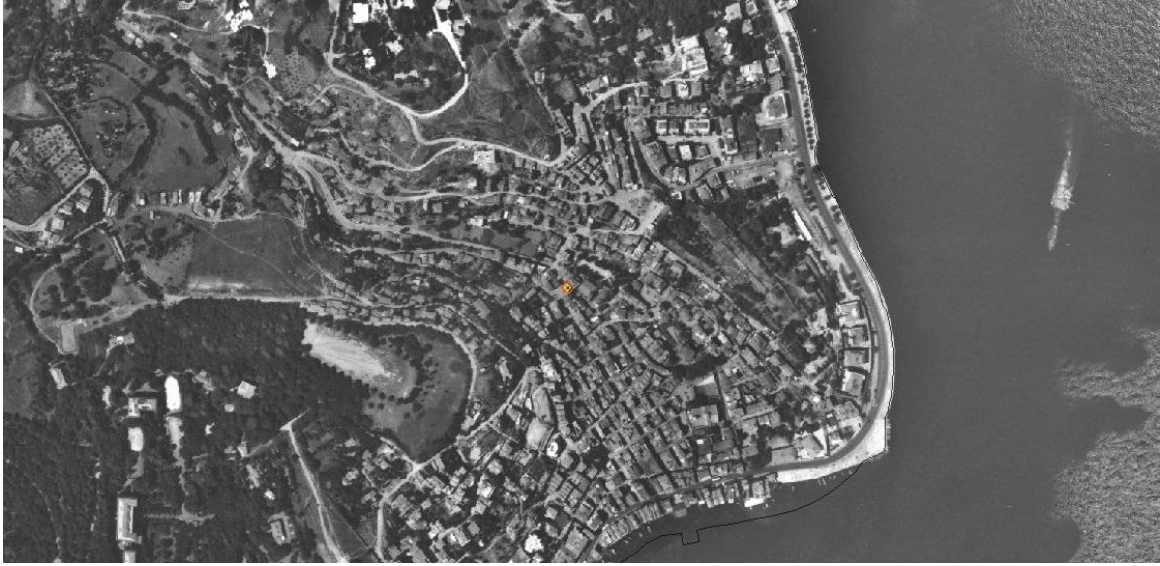
In the figure 33, there is a rapid increase of structures which were divided with narrow streets and majority of these buildings were surrounded around the coastal area whereas upper hills were still surrounded with trees but there were signs of squatter houses.

Figure 33: A map of Arnavutköy (1982) in the scale of 1/5000

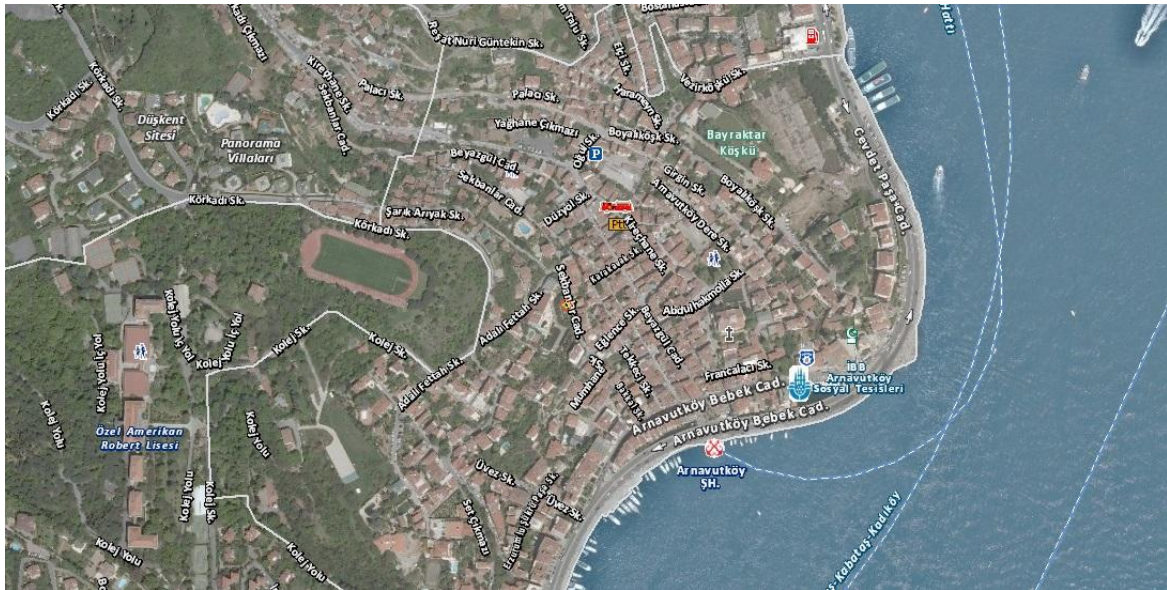
In the figure 34, the boulevards and open spaces with some landmarks and the widening of coastal road opened up the historic area of Arnavutköy and made timber structures more visible for people to appreciate.

Figure 34: Aerial map of Arnavutköy in the scale of 1/5000

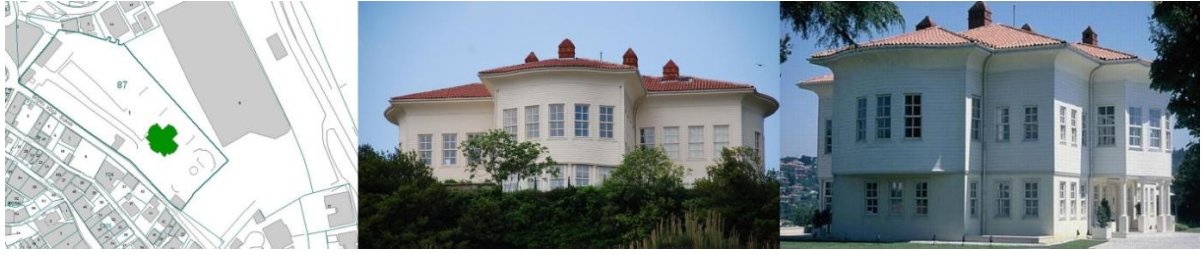
Figure 35: İzzetabad Kasrı

This timber clad concrete structure is built by İzzet Mehmet Pasha in the second period of 18th century and it has 8 columns in the entrance as in the figure 37.

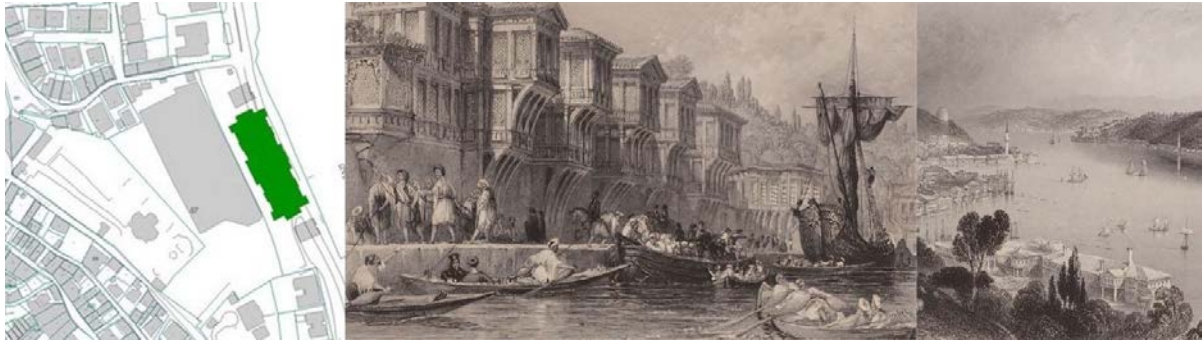
Figure 36: Beyhan Sultan Palace

Beyhan Sultan Palace was located in the place of Çifte Saraylar as in figure 38.¹¹² After the emperor II.Mahmuts daughter got married with Sait Paşa, it became known as Sait Paşa Yalısı.¹¹³ In the period of the Ottoman ruler Abdülmecid, this palace was demolished and rebuilt with brick clad on the exterior, timber in the interior.¹¹⁴ It was completed in 1856.¹¹⁵ In

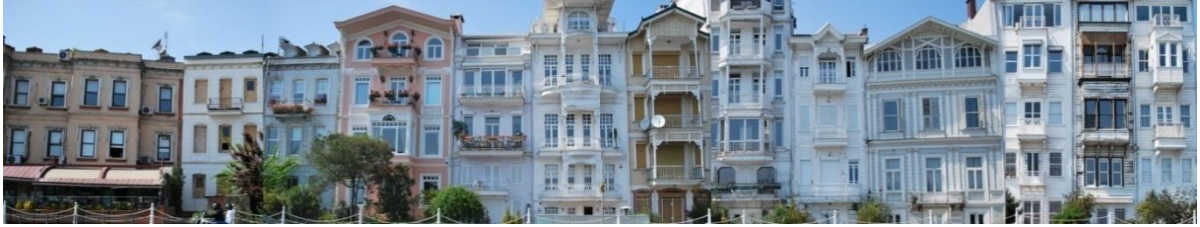
Figure 40: Facades of yalis along the Bosphorus in Arnavutköy

The most striking feature of Arnavutköy is its yalis along the Bosphorus coast and as in the figure 40, facades of these seaside structures are preserved and in the plate 6, the section along the Arnavutköy- Bebek Street signifies the horizontality of the coastal settlement but in comparison to the inland structures, it reveals vertical impact in the area.

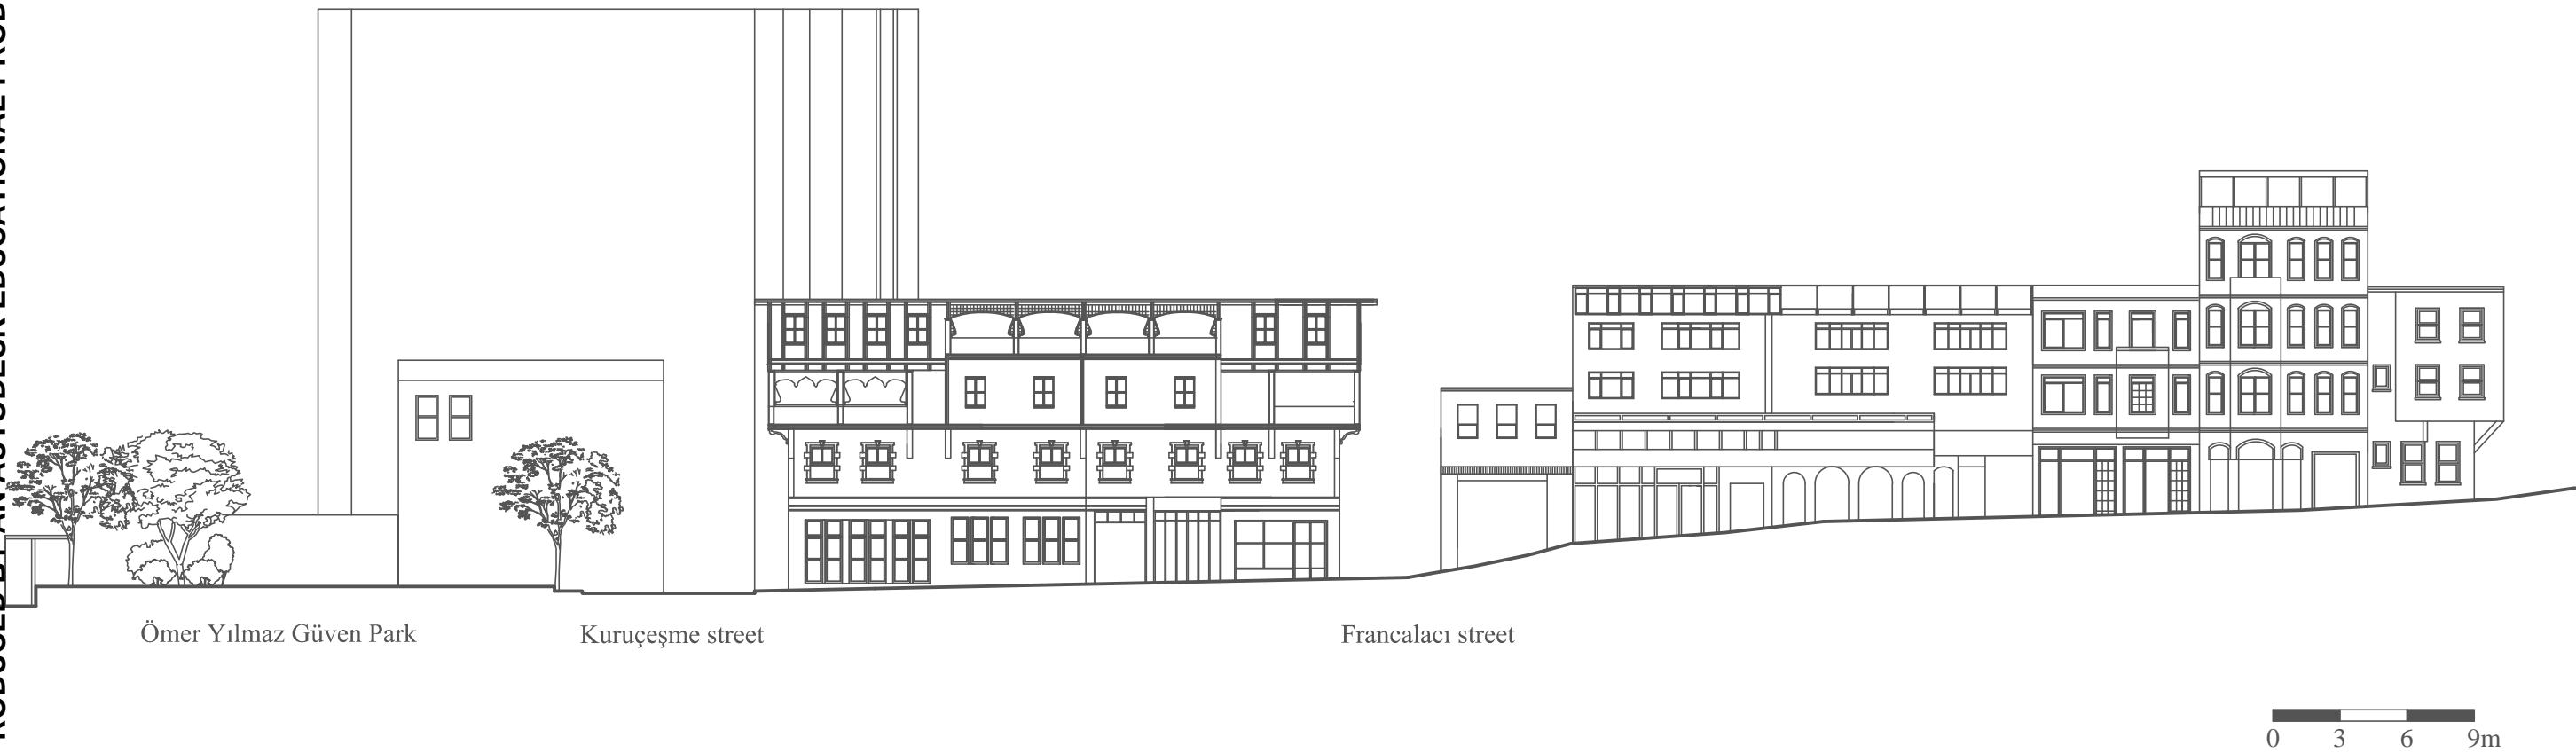
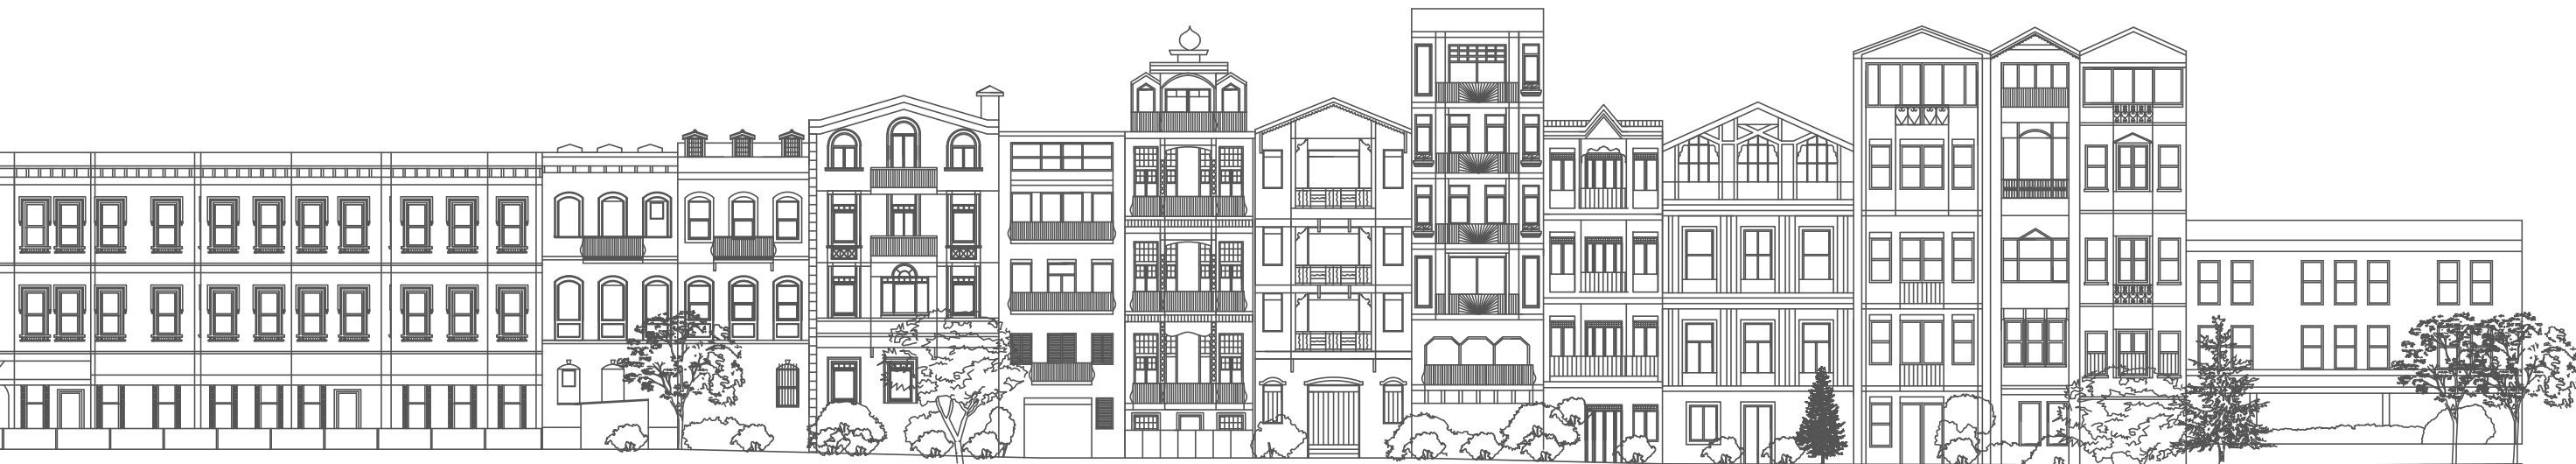
PLATE 6

On the other hand, the perpendicular street to the Arnavutköy- Bebek Street, Beyazgül Street's partial section as in the plate 5, reveals that behind the yalis, there are buildings which are more modest in height as the topography gets slope up towards to the hills. The front facades of these buildings which face to the Beyazgül Street become wider and additional floors can be seen. In addition to that, as in the plate 5, Beyazgül Street facade view is not preserved as it is in the yali example as in the plate 6. The timber clad material is used less and the carvings, decorations cantilevered overhangs are not dominant on Beyazgül Street when it is compared to yali views. The use of reinforced concrete material in buildings is mostly seen on Beyazgül Street and it is not compatible with historic building facades.

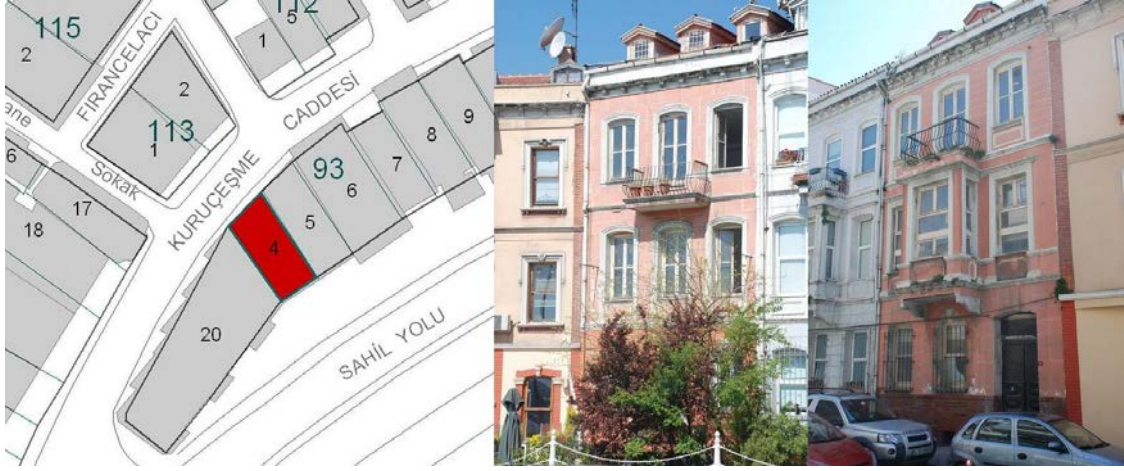
As seen in figure 41, listed “Yalı”s, summer houses along the Bosphorus shoreline mostly 20th century buildings that are built in Turkish Republic.

Figure 41: One of the listed yalis along the Bosphorus shoreline, building no: 4

There are two entrance facades; one on the front and the other one on the rear. Today it is not in use and it has a bay window on the rear facade which is used as a balcony at the upper floor. On the frontal facade, there is a balcony at the second floor, three openings that are covered with gable roofs. The windows are shaped with depressed arches. Under the ground floor windows, the facade is covered with brick.

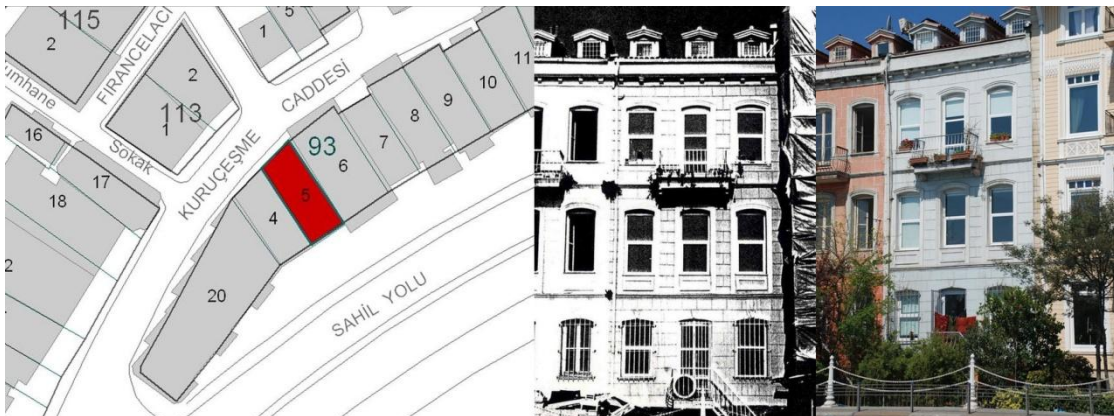
Figure 42: One of the listed yalis along the Bosphorus shoreline, building no: 5

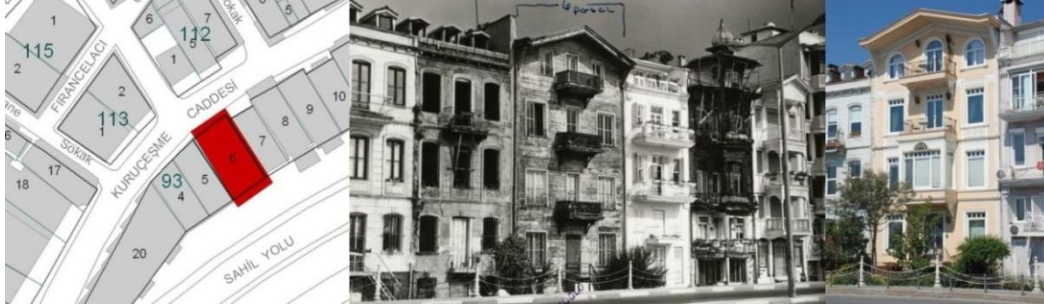
Brick, stone structure has stone clad facade, depressed sash windows and in second floor there is a balcony and a “cumba” which faces to Kurucesme Street as seen in figure 43.

Figure 43: One of the listed yalis along the Bosphorus shoreline, building no: 6

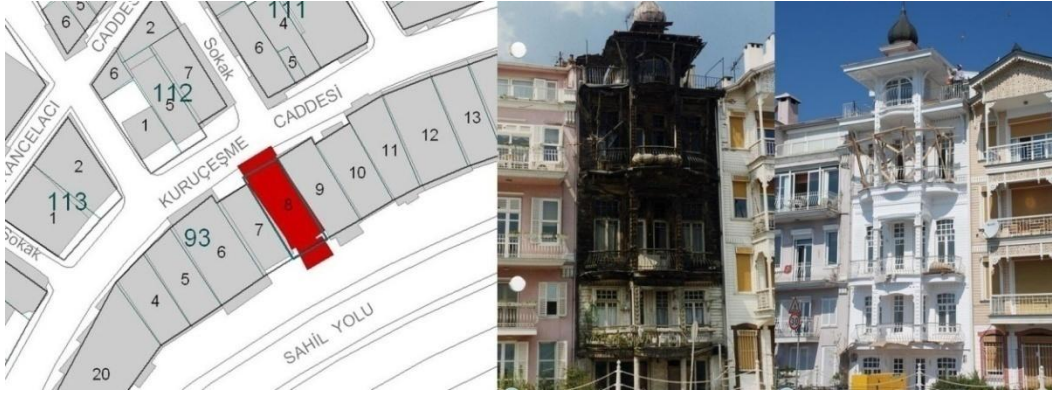
This stone masonry structure has balconies at each floor as in the figure 45.

Figure 45: One of the listed yalis along the Bosphorus shoreline, building no: 8

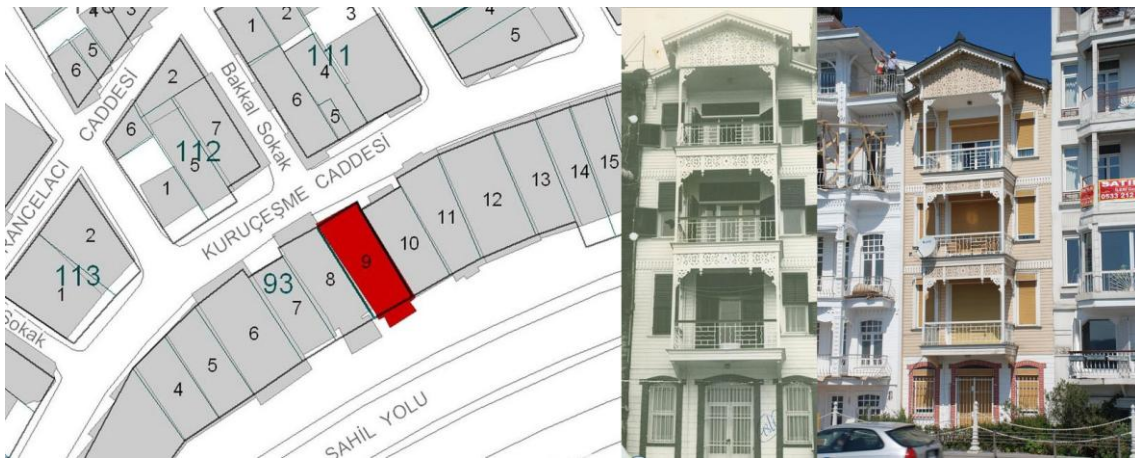
Timber, stone and a reinforced concrete structure have distinctive features including balconies, two supporting columns at each floor and onion shaped dome on the roof as seen in the figure 46. The top floor is known as “cihannüma” which is a tower looking floor that is covered with glasses and underneath the eaves of the roof there are geometric shapes ornamentations.

Figure 46: One of the listed yalis along the Bosphorus shoreline, building no: 9

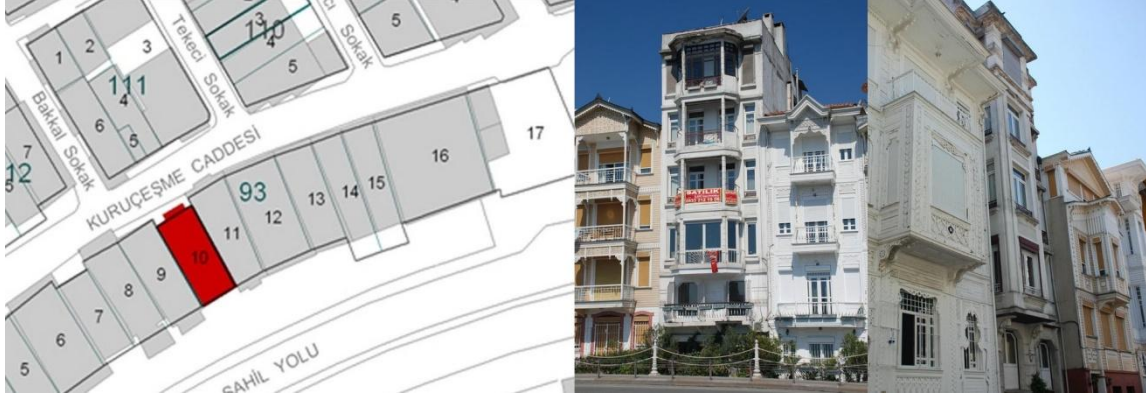
The yalı has projected balconies which are known as cumba, and on the ground floor facade openings are shaped with brick arches as in figure 47. There are wooden craft ornamentations on the frontal facade which faces to the shore road.

Figure 47: One of the listed yalis along the Bosphorus shoreline, building no: 10

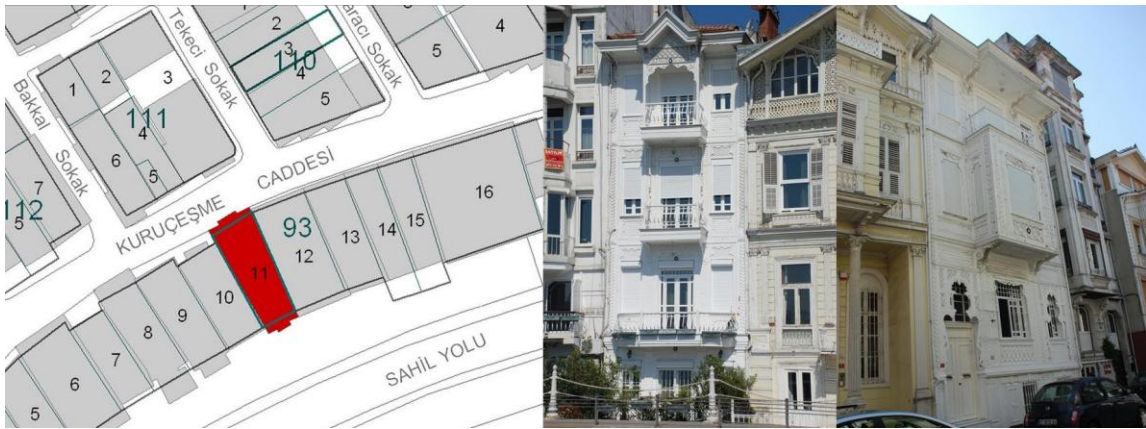
The reinforced concrete structure has balconies at each floor which starts from the first floor and these balconies are supported with two columns and on the rear facade there is a rectangular projected part as seen in figure 48. Its authenticity remains still even though the structure material has changed.

Figure 48: One of the listed yalis along the Bosphorus shoreline, building no: 11

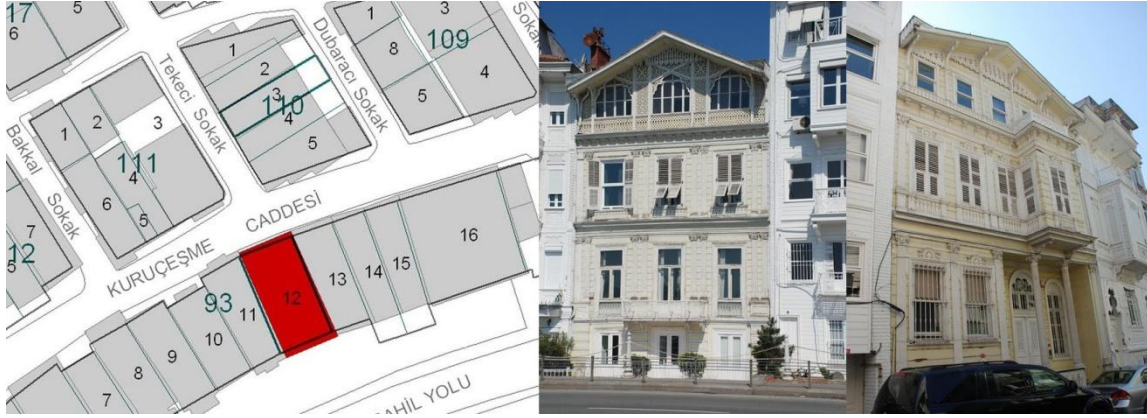
The brick masonry structure has plaster on the facade and in the second floor it has “cumba” and in the upper floor it continues with a balcony. In the ground floor on the frontal facade the balcony has an oval plan but in the 1st and 2nd floor the plans of the balconies are rectangular as seen in figure 49.

Figure 49: One of the listed yalis along the Bosphorus shoreline, building no: 12

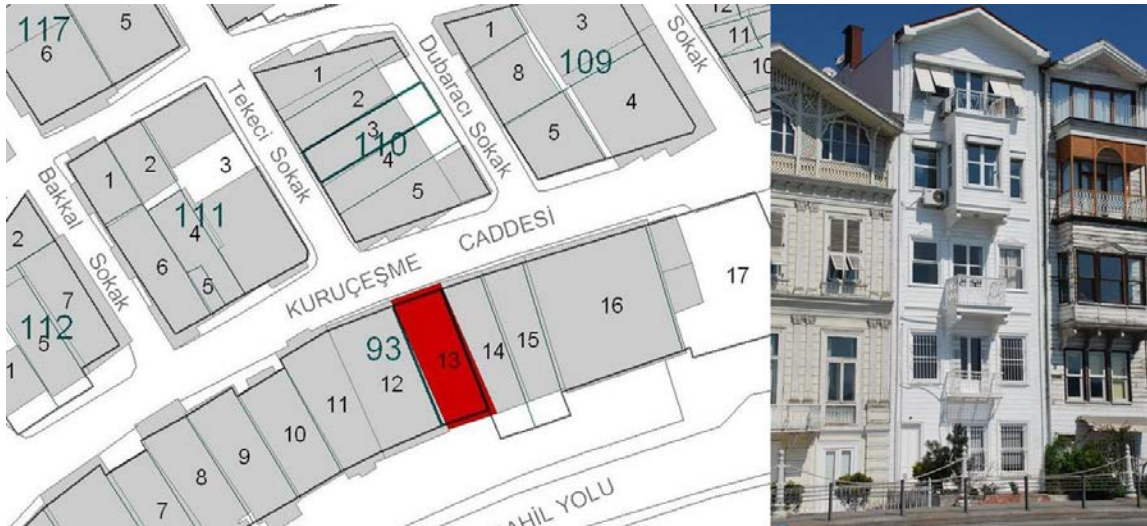
There are columns with relief printing designs at each side of windows and the top floor timber facade is decorated.

Figure 50: One of the listed yalis along the Bosphorus shoreline, building no: 13

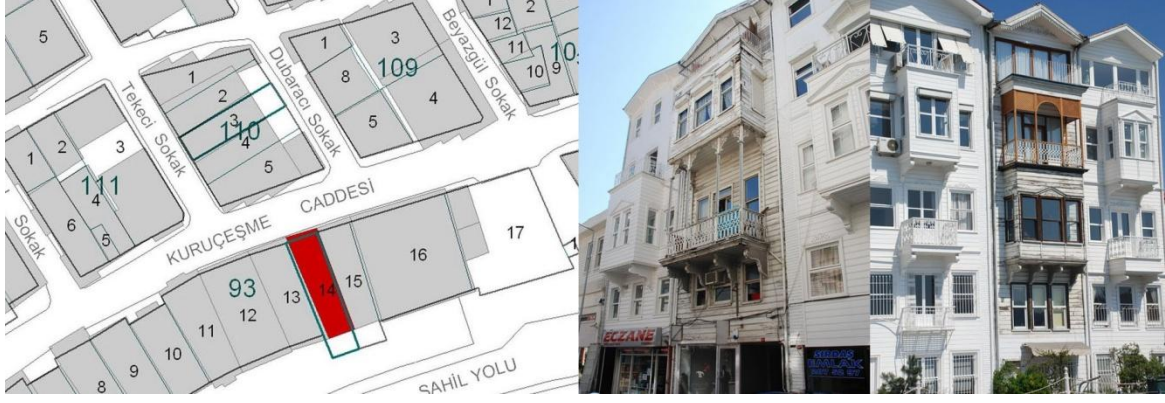
Its structure is reinforced concrete and the facade is timber. On the frontal facade, there are balconies at 1st and 2nd floors whereas the projected part at the third floor is used as balcony in the upper floor as seen in figure 51.

Figure 51: One of the listed yalis along the Bosphorus shoreline, building no: 14

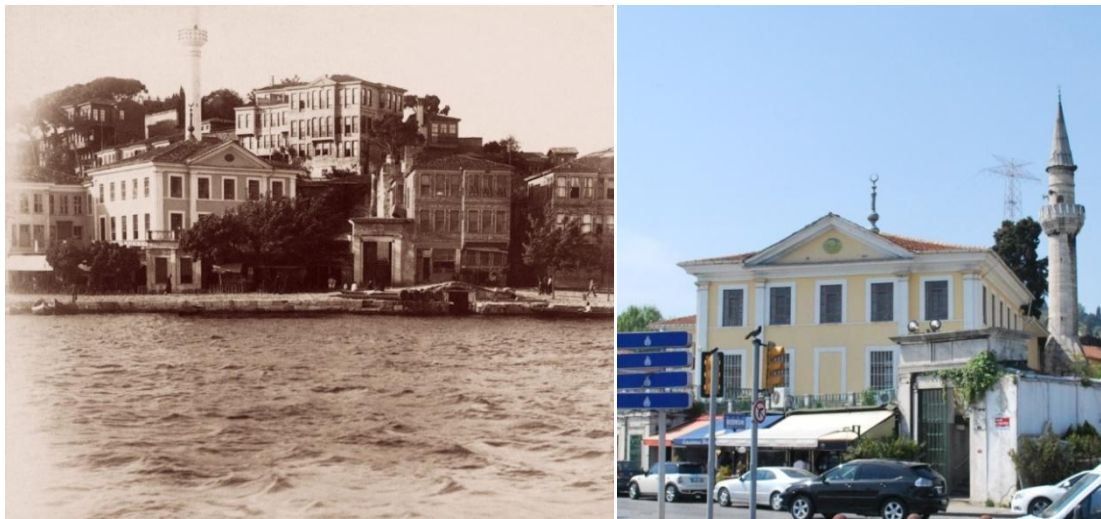
Tevfikiye mosque which was built in 1832 is located next to the historical building; police station. In this period, Ottoman architecture evolved in terms of westernization, classicism, and neoclassicism which brought antique architectural components such as columns, arches and austere pediments and these elements are reflected on the mosque's facades. The rectangular planned mosque has one minaret, it comprises of ground floor and first floor. Its roof is a timber structure and roof covering is tile roof. The mosque has a brick masonry structure, a courtyard which is located in a high terrace. Its entrance door has inscription on it.

Figure 53: Arnavutköy Tevfikiye Mosque

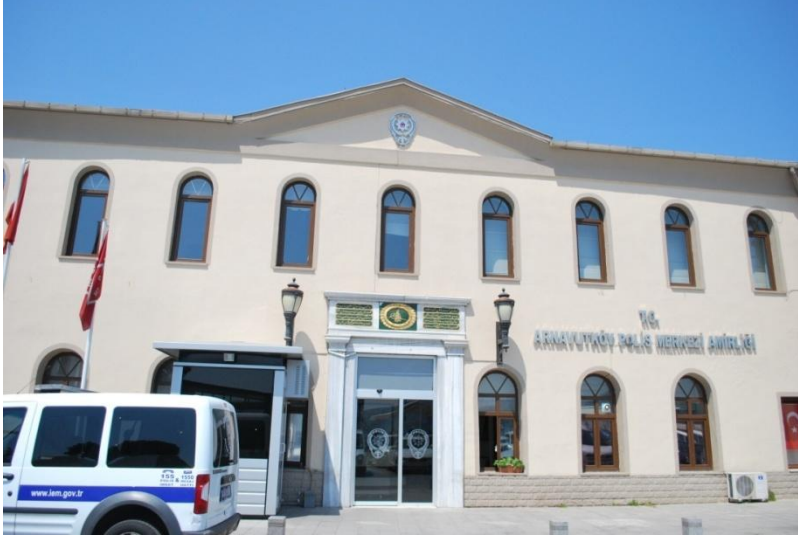
facade has three pediments and only one entrance and it has a wide backyard. On the frontal facade there is a medallion in the middle and an inscription in “ampir” style which reflects neoclassic Ottoman architecture. The central part of the frontal facade is recessed 2 meters from the two wings as seen in figure 55.

Figure 54: Arnavutköy Police Station

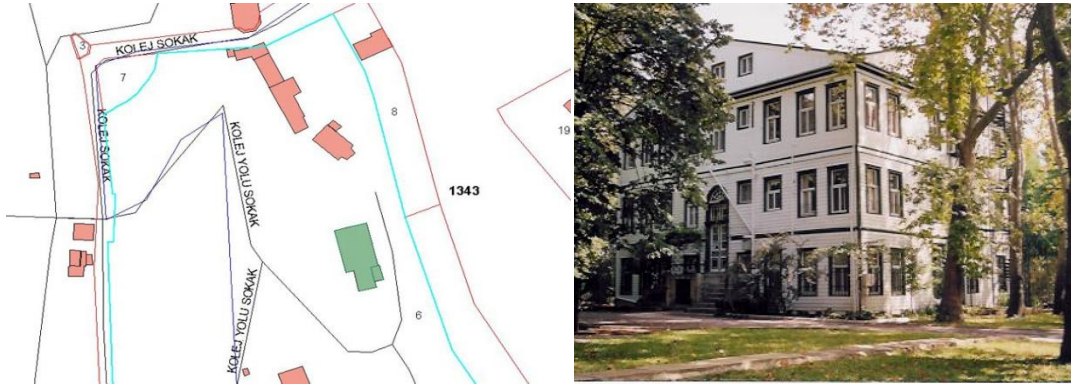
Figure 55: Arnavutköy American Girl College

The listed monument is a timber structure with timber clad has 5 ionic columns.

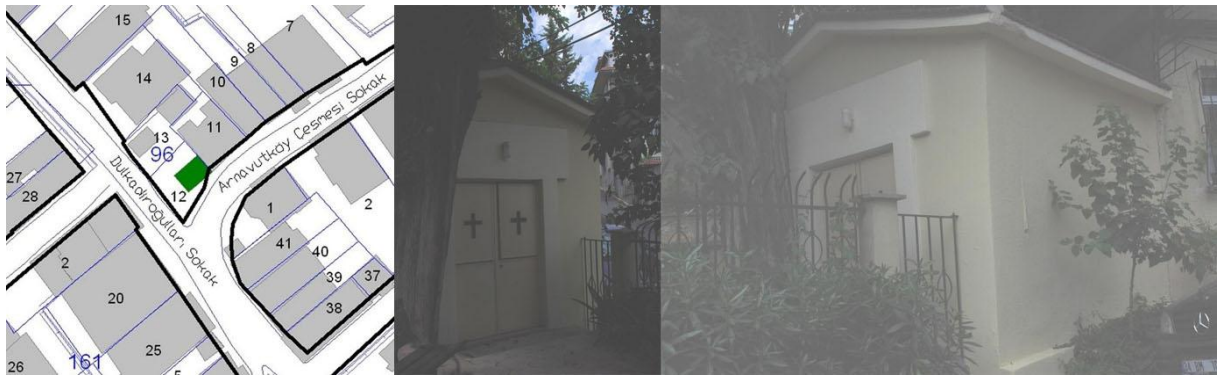
Figure 57: One of the Existing Ayazmas

This masonry brick structure has gable roof and still is functioned as ayazma although it had undergone major renovations, it is listed and in a fairly good state as seen in figure 58.

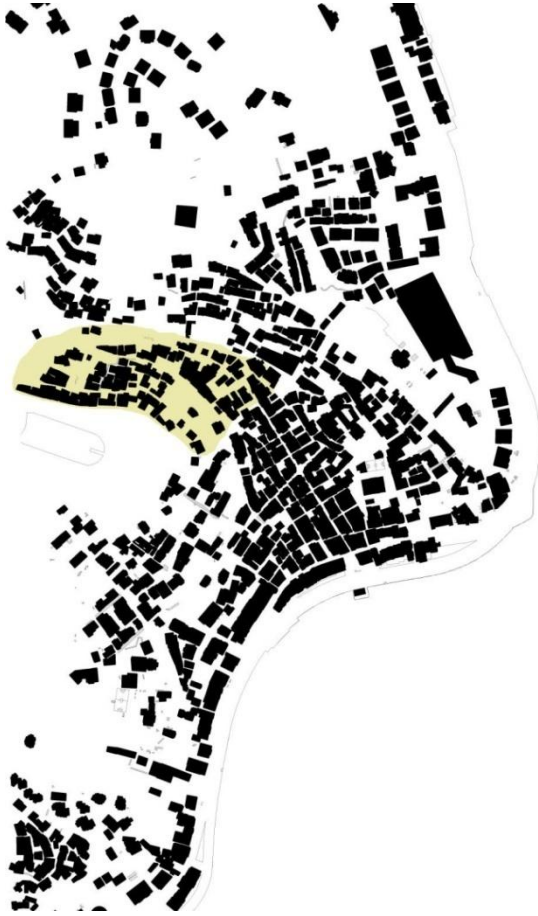
Figure 58: Squatter area

It is clearly seen that there are one or two storey squatter houses that are located on different levels which are connected with steps, on the top of the hills of Arnavutköy especially on the Sekbanlar, Beyazgul, and Kirechane Street as seen in figure 59. In comparison to the other concrete high rise buildings, these houses do not interrupt the silhouette of the area and in fact; it shows that there is a different character of the area where the slope increases. They are built with low budget and these houses have views of Bosphorus from different angles and they do not interrupt their views looking from top of each other as in seen figure 60.

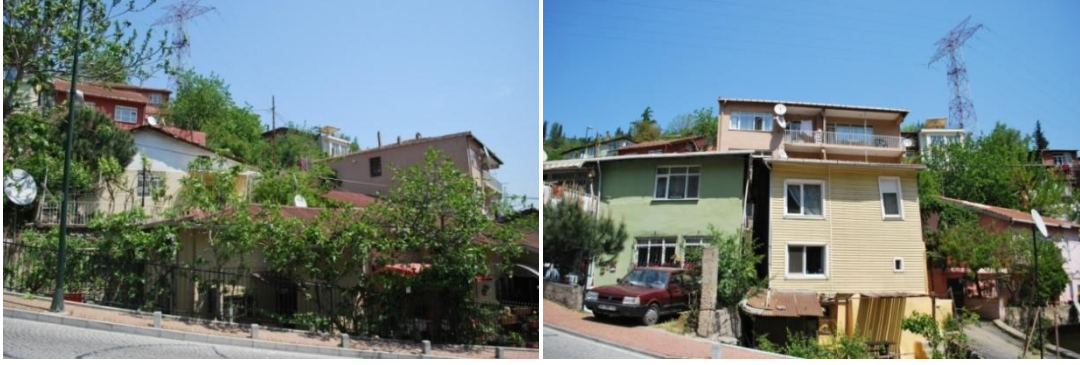
Figure 59: Squatter Houses on Kirechane Street

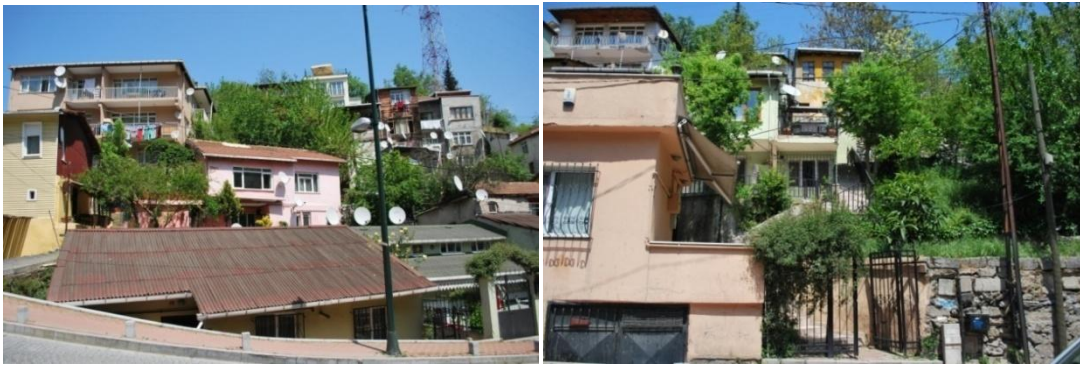
Figure 60: Illegally Built Houses up on the Hills of Arnavutköy

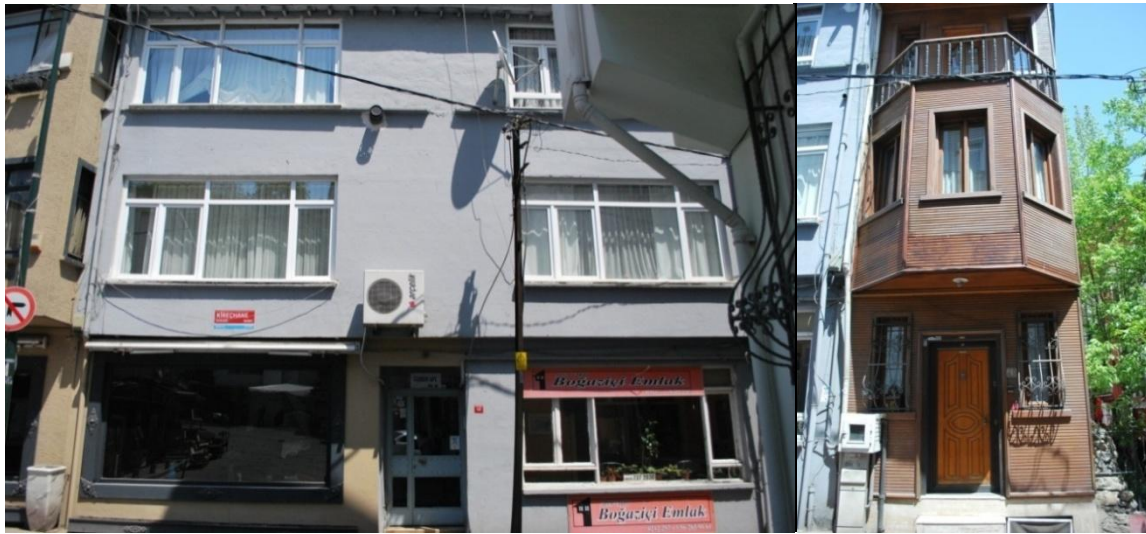
Figure 62: Building Facades on Kirechane Street

On the parallel street of Beyazgul Street, Kirechane Street, reinforced concrete structures which were built in recent years do not follow the similar facade view as the historic buildings do, as seen in figure 63. The streets in Arnavutköy are narrow, stepped, sloping but the new buildings on the streets have wide facades which contradict with the traditional houses which have narrow, timber clad facades with balconies, bay windows that overshadow streets, as in the figure 64.
